Expert Commercial Building Inspections LLC

Property Condition Report 369 South 900 East, Salt Lake City Utah 84106

Inspector: Garrett Merrick
Inspection Date: March 2012
County Property #123456789

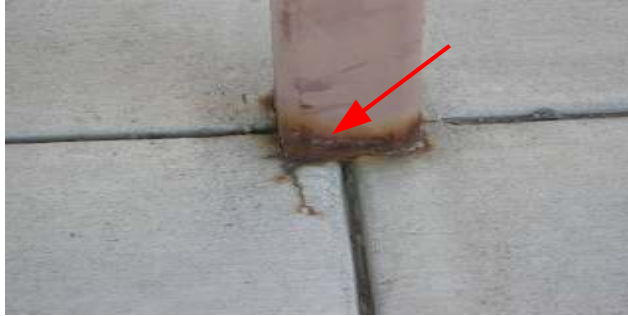
The canopy pillars on the southwest corner of the building have minor rust at the base.

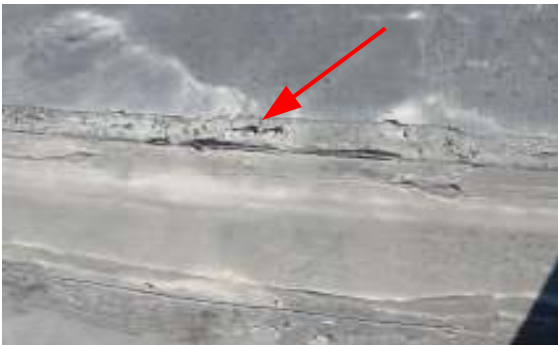
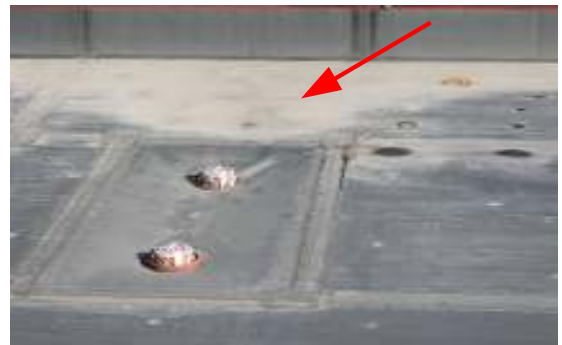
The lap sealant on the overlapping glued seams is showing signs of deterioration on the older west half of the roof. Deteriorating lap sealant creates more opportunities for the membrane glued seams to leak; they should be inspected regularly and resealed. Some evidence of ponding (pooling water which can accelerate membrane deterioration) was observed, particularly on the north lower roof.

1. Re-seal the deteriorating roofing membrane laps on the older west side.
2. Repair the leaking roof drain at column 2G.
3. Keep the roof access hatch locked.
4. Repair the malfunctioning roof exhaust fans.
5. Repair or replace the deteriorated gas piping standoff blocks.

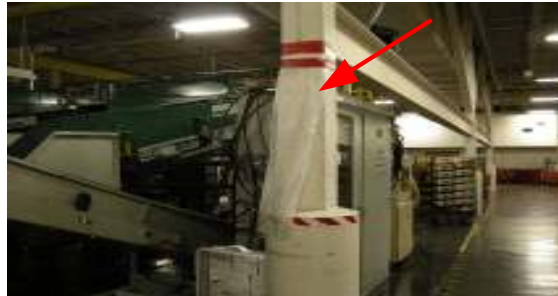
The roof drain pipe at column 2G shows evidence of leaking. This drain pipe is smaller, and it probably fills up during very heavy rains and leaks at the under-membrane attachment point.

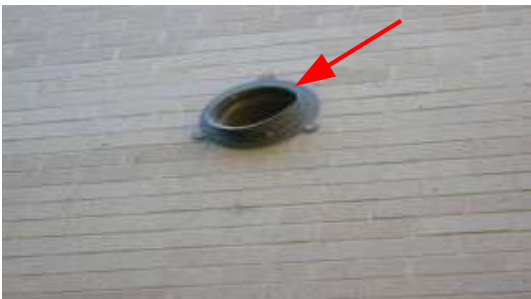
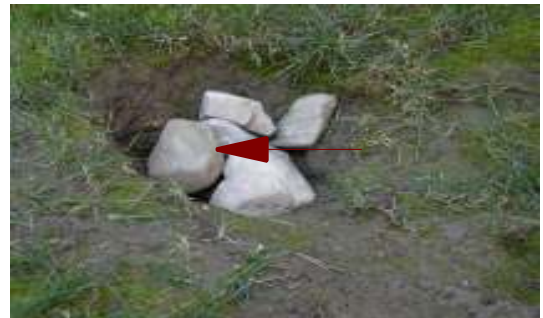
- all have covers, some metal, some plastic
- some drain onto lower roof (north & south); some drain into south parking lot storm drain system
- roof drains are relatively clean, a sign of regular maintenance
- No gutters; no downspouts
- minor damaged interior insulation
- [evidence of one minor interior leak](#)
- some drain onto north grass; [splash blocks should be installed.](#)

1. Install roof drain splash block on the north grass area.
2. Repair rust on bollards to prevent further deterioration
3. Straighten and re-weld the truck gate to prevent damage to the gate operator.
4. Repair the inoperable exterior lights
5. Replace the missing light fixture on the west side

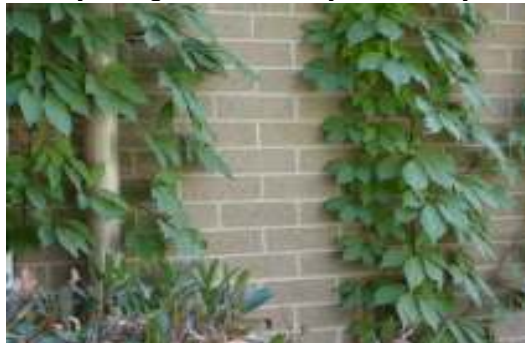
Trees on the east and north extend above the roof line, but minimally over the roof. The east entrance decorative rock and dirt area is weedy; the decorative rock area on north is weedy, Virginia Creeper going up the wall on the north side by the gas meter may adversely affect the structure

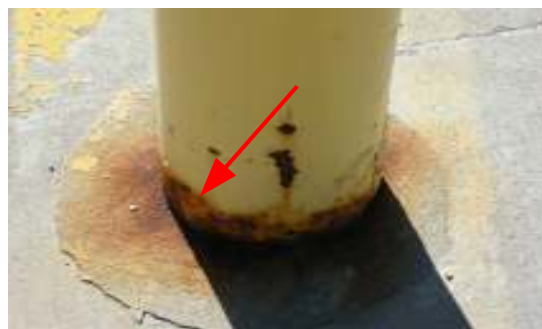
- chain link, 6' and 8'; some topped with barbed wire strands; some strands are loose
- no top rail on fence between truck parking area and employee parking area
- some fence posts show evidence of having been straightened; some fence denting
- Outdoor bollards are serviceable; some rusting at the bottoms is visible.

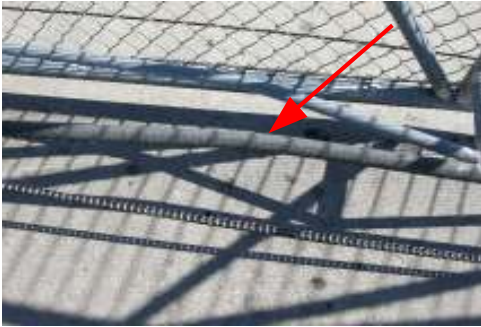
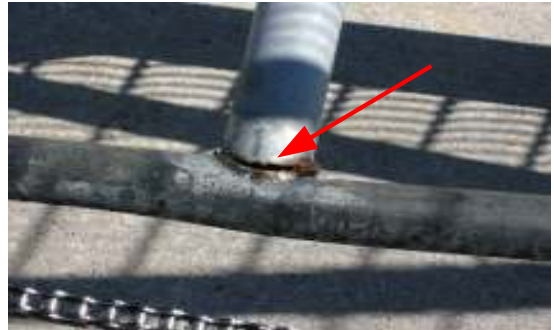
- Some rust; some welded repairs
- A bend in the truck gate should be straightened and re-welded

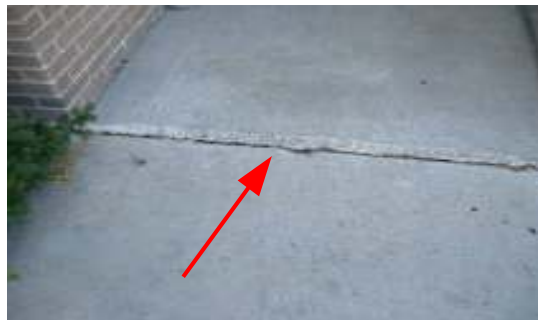
- minor cracks; no trip hazards
- some spalling and settling in areas
- some settling by north "mail collection" door

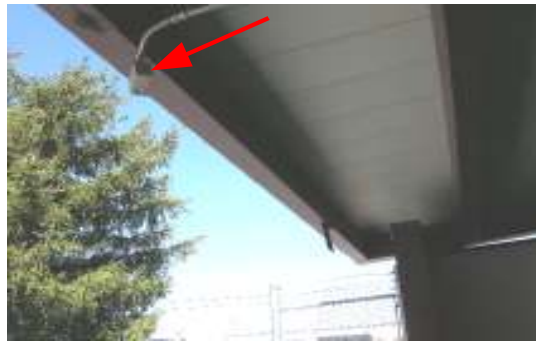
- lights at base of northeast flagpole do not work; an alternate flag light has been installed on the light pole to the west of the flagpole
- an exterior **light fixture has been removed** under the west parking canopy.

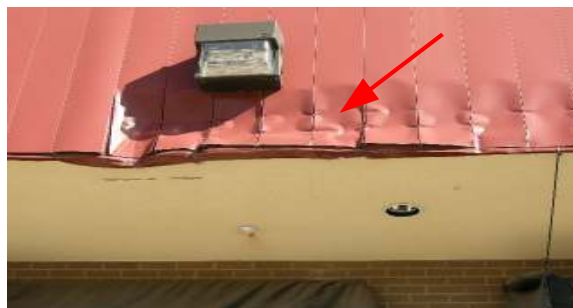
Siding, flashing and trim, eaves, soffits and fascias: The exterior siding is mostly brick, with much glass on north and east sides. The south side soffits have access panels (3) outside near doors 12, 28, and the personnel ramp. Some minor damaged soffit and aluminum fascia was observed above dock doors.

1. Paint expansion joint expanding foam to prevent deterioration.
2. Repair soffit and fascia areas above the dock doors.
3. Repaint the step-down ledge in the truck parking lot.

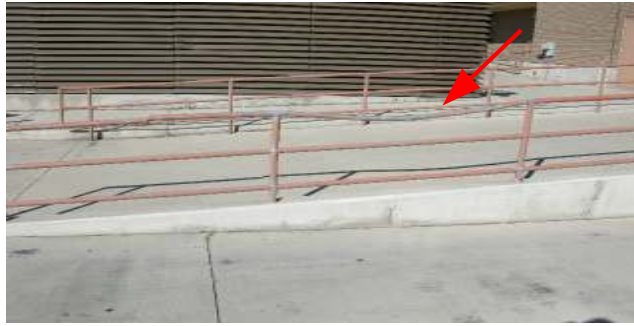
Worn paint was observed on the southeast ramp rails. The rail is bent in one spot and broken in another on the south side loading ramp,

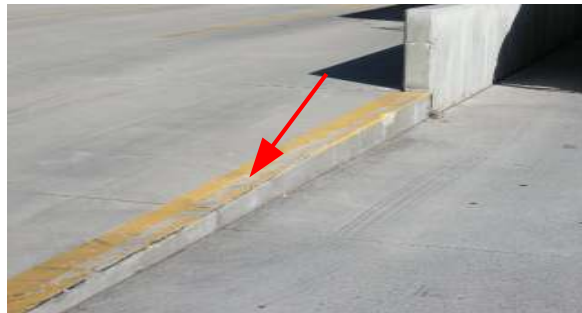
The faded paint on the step-down ledge in the truck parking lot requires repainting for safety visibility.

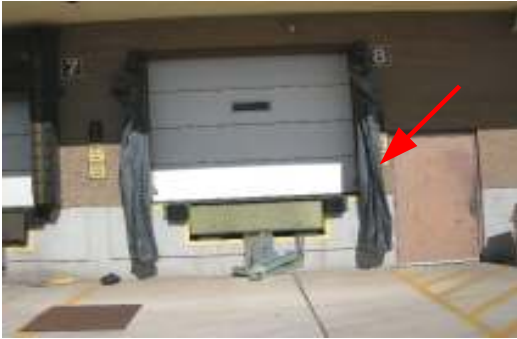
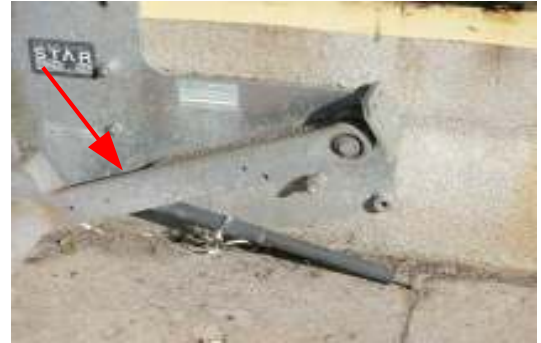
- all are operational
- all have working latch bars
- all have torsion springs; some need adjustment
- some damaged or deflated overhead/side truck bumpers on the outside (left photo)
- some inoperative and/or loose trailer restraints (right photo)

1. Repair truck bumpers and trailer restraints.
2. Repair loose lens and lamp guard on the trailer door light.
3. Repair the red/green truck movement lights.
4. Repair entry door panic bar.

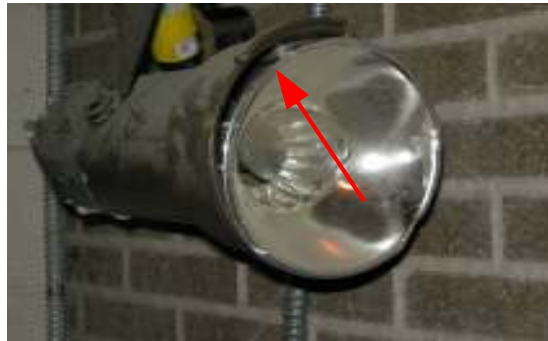
The swinging arm truck loading lights are operational; some lamp guards are missing. There were no exposed electrical hazards, except for [loose lens and no lamp guard on the trailer light by the compactor](#).

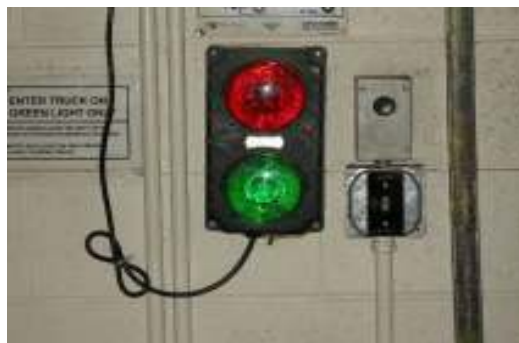
Some lights were not working on the [red/green truck movement lights](#)

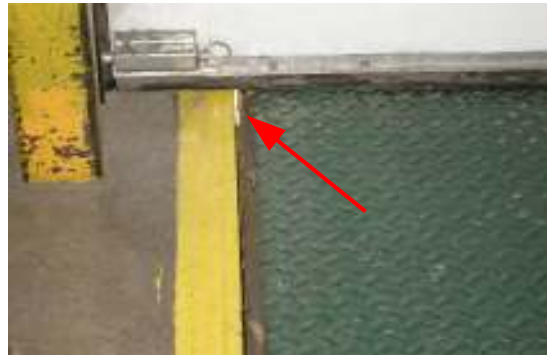
Dock Levelers: All are operational; some recently painted, some not. Large air gaps will allow a lot of air infiltration.

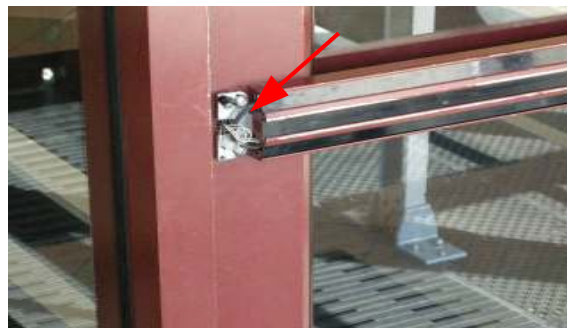
Missing end part on east (front) inner exterior (entry) door panic bar

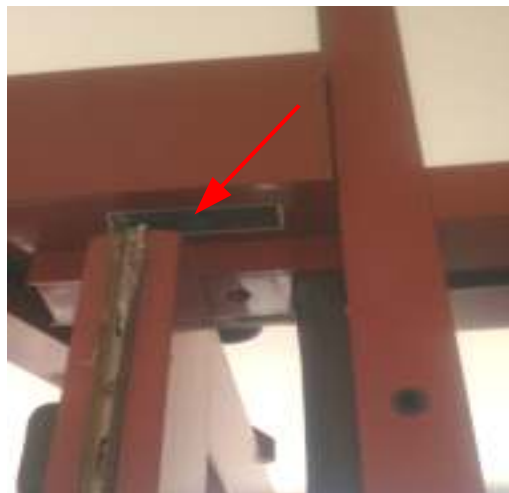
East automatic doors have pin-type hinges which can loosen, making the door fall off (potential safety hazard) if the adjusting screw is not periodically inspected and kept tight.

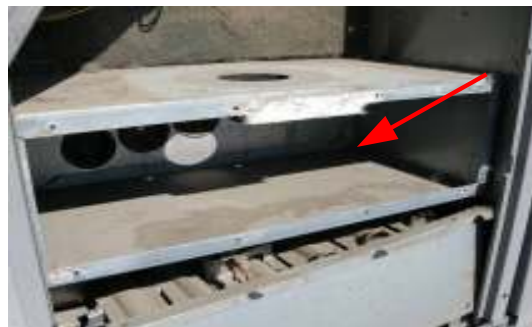
RTU 2 did not produce heat in the heating mode. The induced draft motor (IDM) is missing from RTU 4; therefore, the heating mode will not work.

1. Add refrigerant to the chiller
2. Verify that the owner has the required EPA refrigerant records.
3. Repair heating mode in RTUs 2 and 4.
4. The HVAC equipment should be monitored and maintained monthly by qualified technicians or a commercial HVAC company.

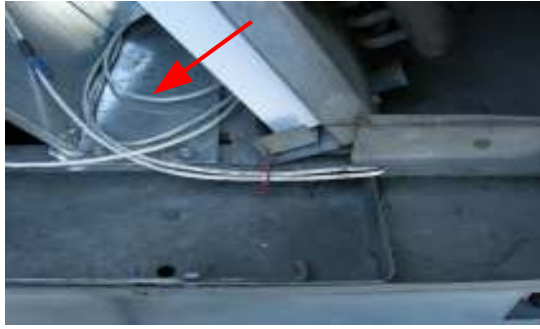
The medium-sized RTUs have wires that are located such that they can be damaged when sliding the filter carrier during filter changes. Maintenance personnel will need to be cautious.

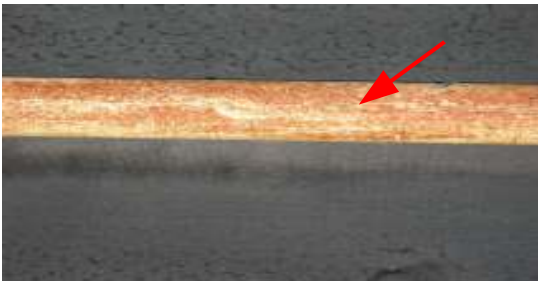
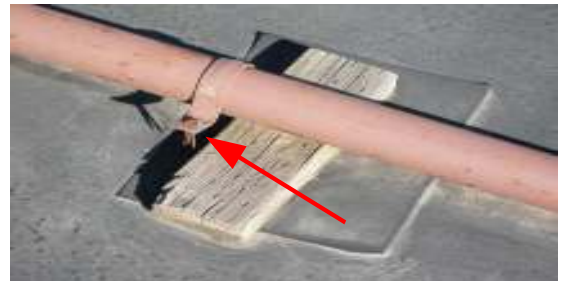
Some gas piping has deteriorated paint (left photo). Some gas piping standoff blocks (prevents pipe leaks and roof damage) on the roof are deteriorated or missing (right photo).

1. Repair and/or replace gas piping standoff blocks on the roof.
2. Test the water supply backflow preventer yearly.
3. Repair the small leak on the tenant-added copper water line on south lower roof.
4. Repair the hot/cold reversed faucet in north women's rest room.
5. Repair the cracked urinal in north men's restroom.
6. Clean out the non-draining floor drains.
7. Label the un-labeled gas piping.

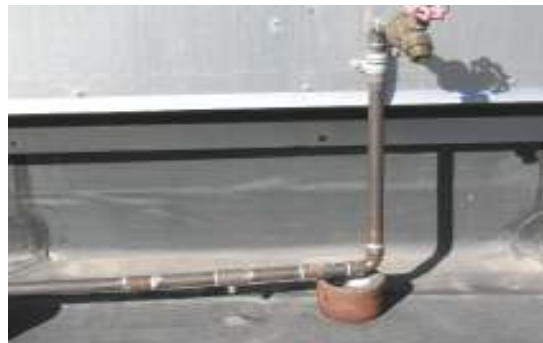
There is a tenant-added copper water line on south lower roof which has a dead-end slope that will trap water and freeze in winter. The supply line shutoff valve must be closed (mechanical room), and the relief valve on the roof must be opened to drain the line before freezing weather. This line appears to have a **small leak** toward the south end.

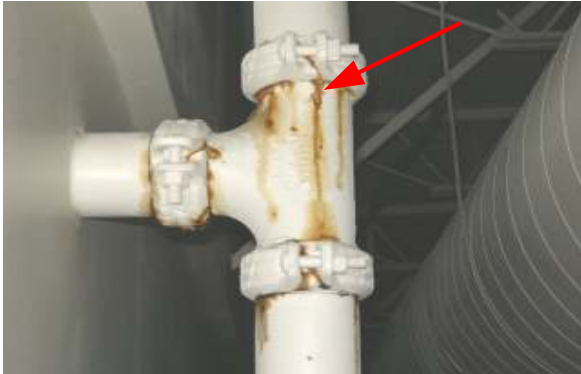
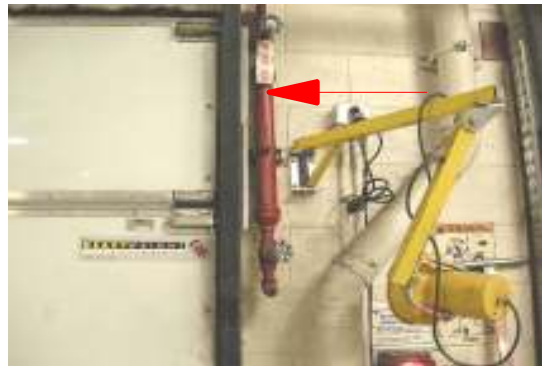
This dry pipe system has substantial evidence of leaking joints (pipes are not painted red in all locations). Maintenance personnel report that the piping is thin gauge, not heavy gauge. Future repairs should be expected. This system has double-valved auxiliary drains (right photo) from which the condensate should be drained each month. The dry pipe system prevents freezing in the fire sprinkler heads which are located outside the dock doors.

1. Monitor the dry pipe joints; replace as needed.
2. Inspect the portable fire extinguishers upon occupancy and correct as needed.
3. Repair the emergency lighting units (replacing the battery usually fixes them).\
4. Repair fire doors and fire dampers as needed.

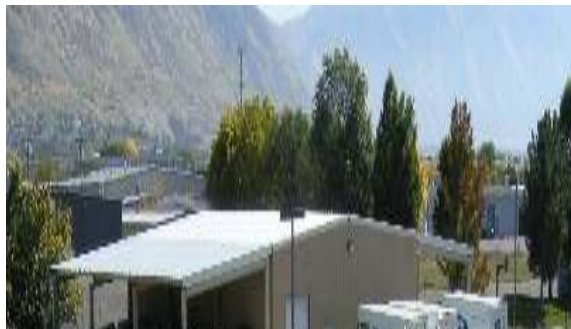
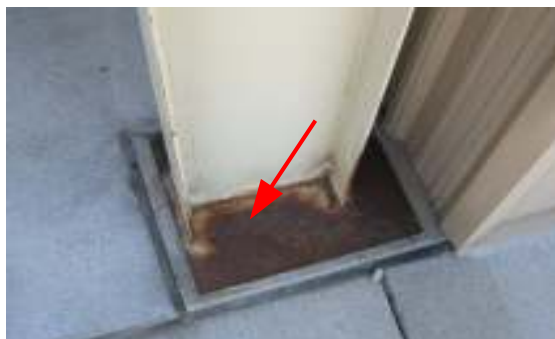
The property includes a detached steel building, approximately 3500 square feet, on the southeast corner of the lot; no signs of leaks. The exterior pillar bases of the steel building have minor rust
