Commercial Building Inspection
Lincoln Avenue, Las Vegas NV 89111
Clark County Property Serial Number 2233445566

Inspector: Garrett Merrick
Inspection Date: 12 March 2012

Building Overview

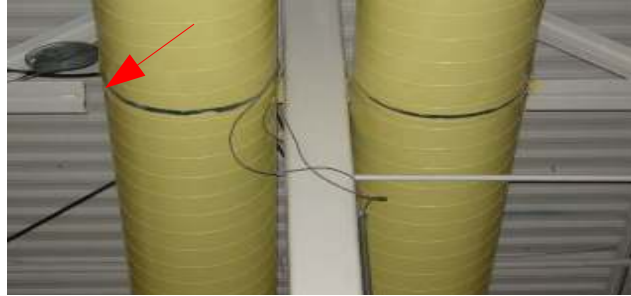
Some trusses (1988) have been modified (east workroom floor by HVAC duct), but have been functioning for 24 years. Have them evaluated by a structural engineer if you have concerns.

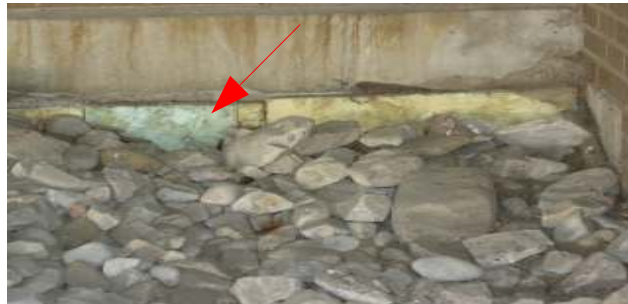
There is evidence on the north side that the foundation was insulated at the time of construction.

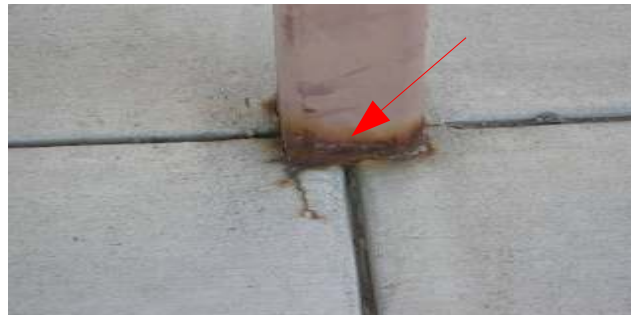
The canopy pillars on the southwest corner of the building have rust at the base.

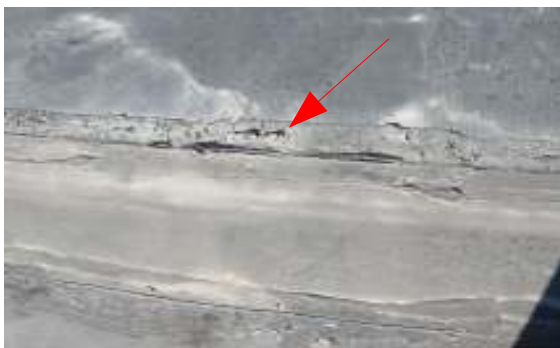
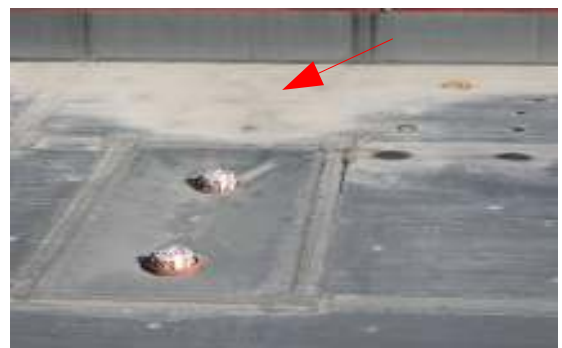
The lap sealant on the overlapping glued seams is showing signs of deterioration on the older west half of the roof; they should be inspected regularly and resealed. Some evidence of ponding (pooling water which can accelerate membrane deterioration) was observed, particularly on the north lower roof.

Recommendations: Seal the roofing membrane laps on the older west side.

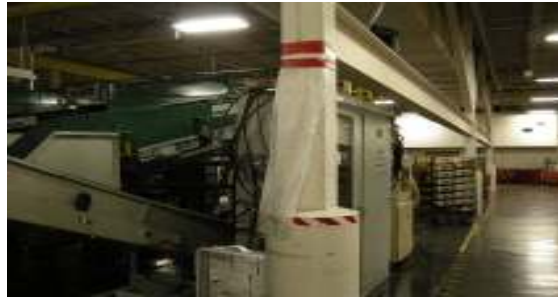
Column 2G shows evidence of leaking. This drain pipe is smaller, and it probably fills up during very heavy rains and leaks at the under-membrane attachment point.

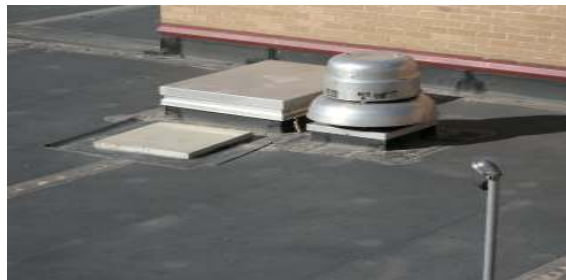
Security item: this roof hatch (south lower roof) was unlocked on the day of the inspection.

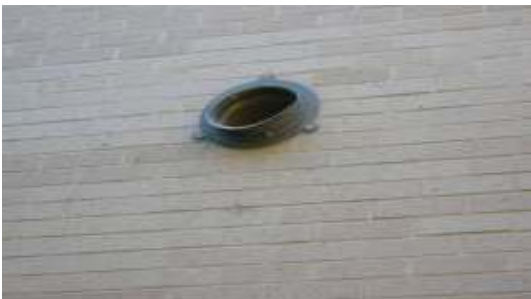
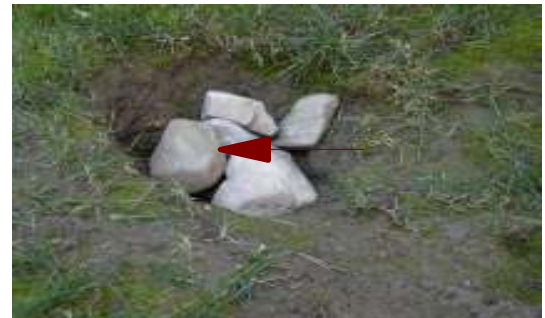
- all have covers, some metal, some plastic
- some drain onto lower roof (north & south); some drain into south parking lot storm drain system
- roof drains are relatively clean, a sign of regular maintenance
- No gutters; no downspouts
- minor damaged interior insulation
- **evidence of one minor interior leak**
- some drain onto north grass; **splash blocks should be installed.**

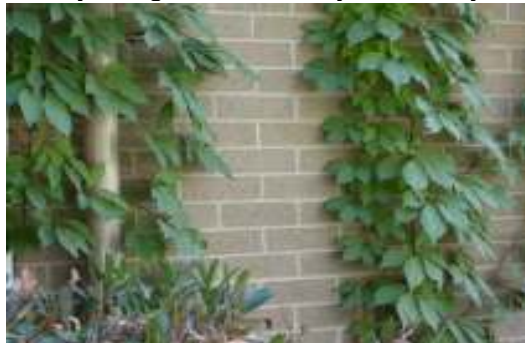
Trees on the east and north extend above the roof line, but minimally over the roof. The east entrance decorative rock and dirt area is weedy; the decorative rock area on north is weedy, Virginia Creeper going up the wall on the north side by the gas meter may adversely affect the structure

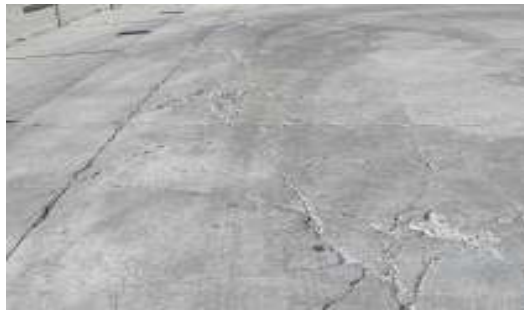
The general topography is basically flat, with sufficient drainage slopes in the parking areas. The parking areas need repainting of the parking stripes. The truck parking area (south) has some deteriorating concrete

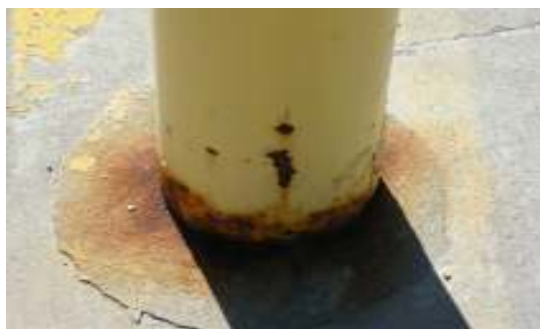
- chain link, 6' and 8'; some topped with barbed wire strands; some strands are loose
- no top rail on fence between truck parking area and employee parking area
- some fence posts show evidence of having been straightened; some fence denting
- Outdoor bollards are rusting at the bottoms

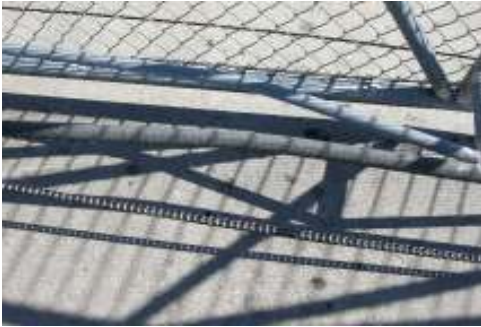
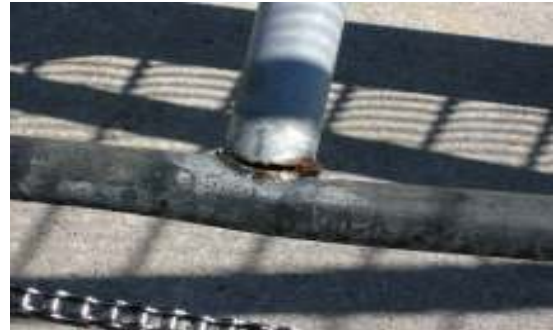
- Some rust; some welded repairs
- **Truck gate is bent**; should be straightened and re-welded

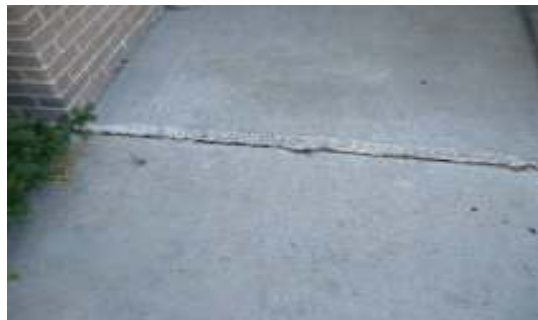
- minor cracks; no trip hazards
- some spalling and settling in areas
- some settling by north "mail collection" door

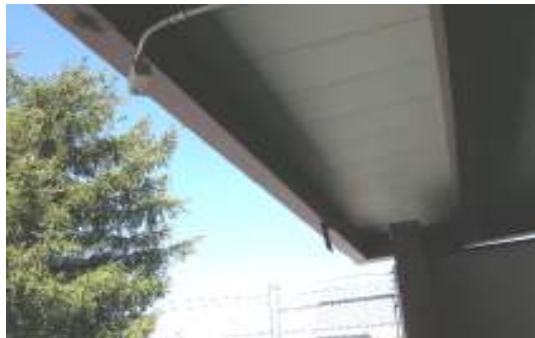
- lights at base of northeast flagpole do not work; an alternate flag light has been installed on the light pole to the west of the flagpole
- Exterior **light has been removed** under the west parking canopy.

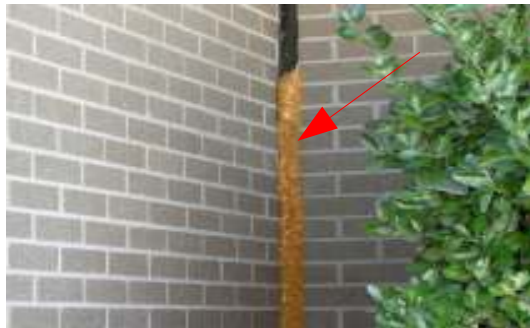
Missing and/or repaired caulking/filler in expansion joints

Recommendations: Repair expansion joints and railing. Repaint parking lot step hazard.

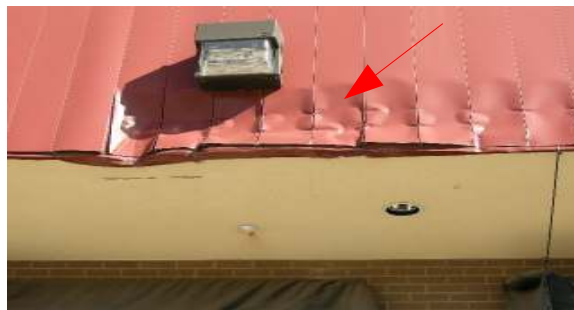
some damaged (minor) soffit and aluminum fascia above dock doors

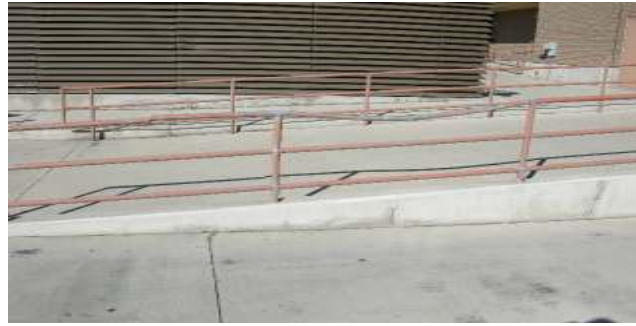
Exterior decks, stoops, steps, stairs, porches, railings: Worn paint on southeast ramp rails. The rail is bent in one spot and broken in another on the south side loading ramp,

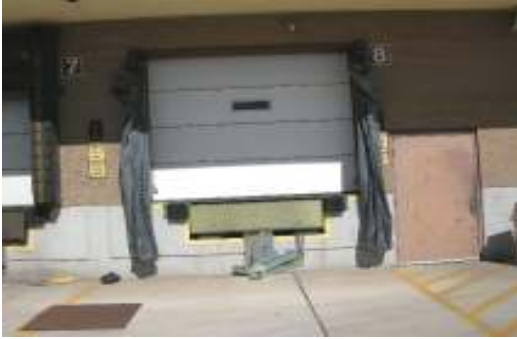
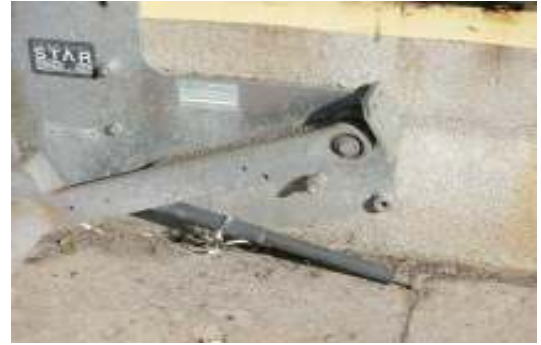
- all are operational
- all have working latch bars
- all have torsion springs; some need adjustment
- some damaged or deflated overhead/side **truck bumpers** on the outside (left photo)
- some inoperative and/or loose trailer restraints (right photo)

Recommendations: Repair truck bumpers, trailer restraints, trailer light, and red/green truck movement lights.

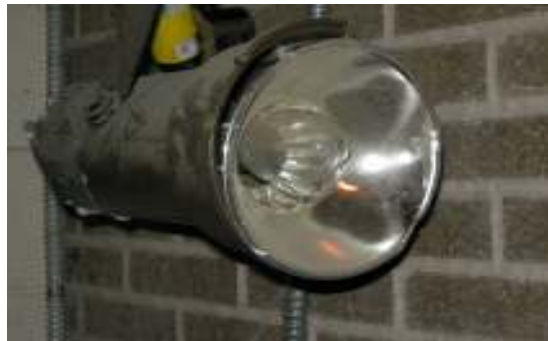
The swinging arm truck loading lights are operational; some lamp guards are missing. There were no exposed electrical hazards, except for **loose lens and no lamp guard on the trailer light by the compactor.**

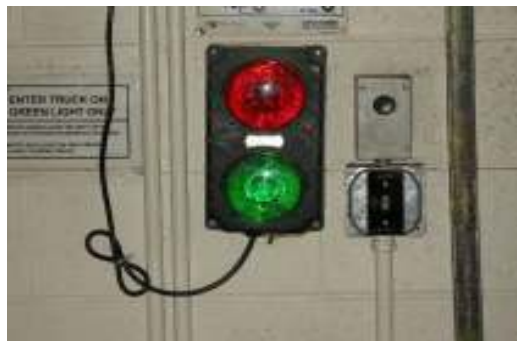
Some lights were not working on the **red/green truck movement lights**

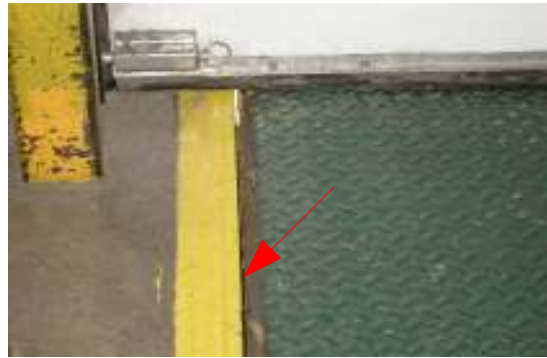
Dock Levelers: All are operational; some recently painted, some not. Large air gaps will allow a lot of [air infiltration](#)

Recommendations: Repair the non-functioning exhaust fans. Seal the dock levelers against air infiltration.

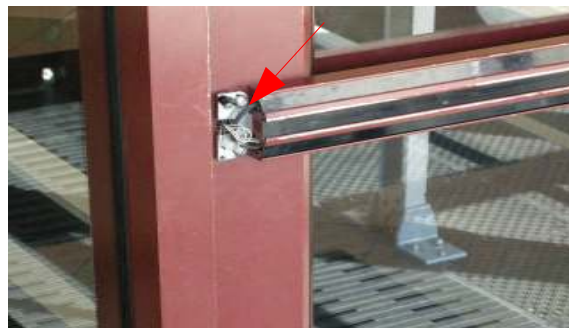
Missing end part on east (front) inner exterior (entry) door push bar

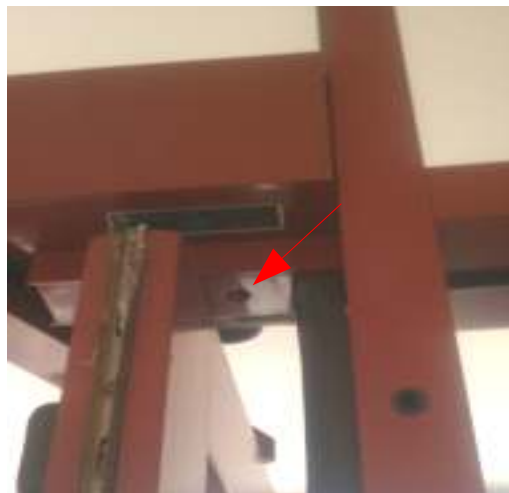
East automatic doors have pin-type hinges which can loosen, making the door fall off (**potential safety hazard**) if the **adjusting screw is not periodically inspected and kept tight.**

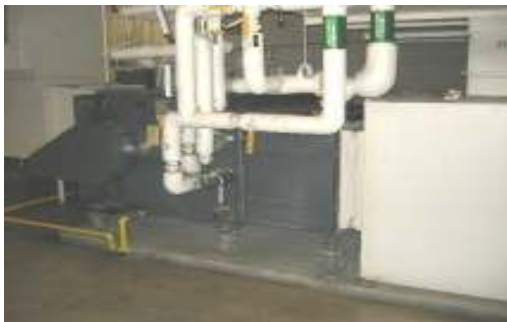
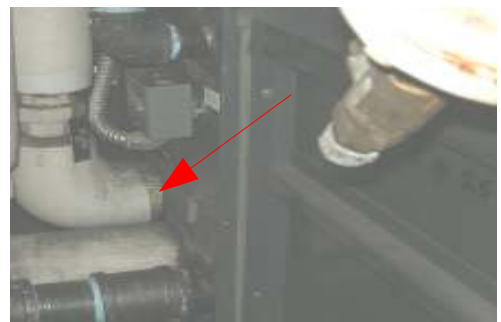
- **AH 3** (11,400 CFM) serves the east half of the east workroom floor. supply fan motor is 3phase, 460V, 7.5hp, with an ABB variable frequency drive (2011). AH 3 shows evidence (plumbing pipes) of the hot water coil having been replaced (2011)

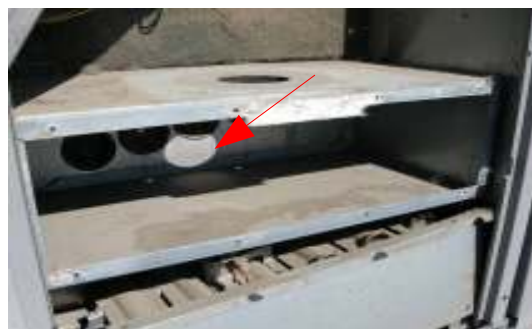
RTU 2 did not produce heat in the heating mode. The induced draft motor (IDM) is missing from RTU 4; therefore, the heating mode will not work..

Recommendations: Repair the heating function in two RTUs and protect the control wires that are in potentially damaging locations. The HVAC equipment should be monitored and maintained monthly by qualified technicians or a commercial HVAC company. [EPA refrigerant records must be maintained for the 120-ton chiller.](#)

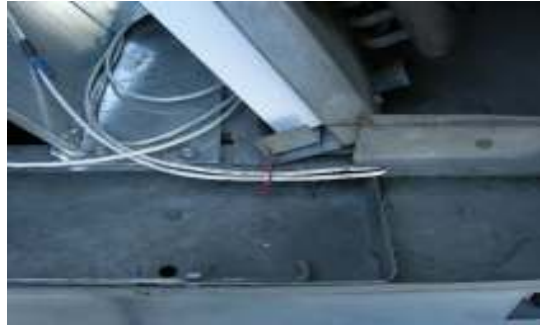
The medium-sized RTUs have wires that are located such that they can be damaged when sliding the filter carrier during filter changes..

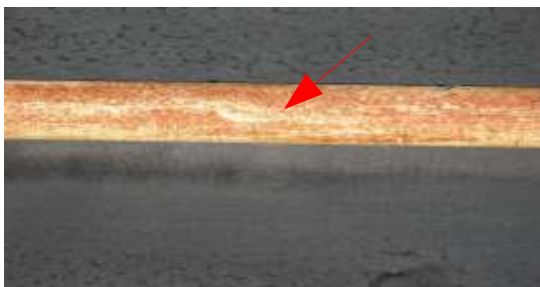
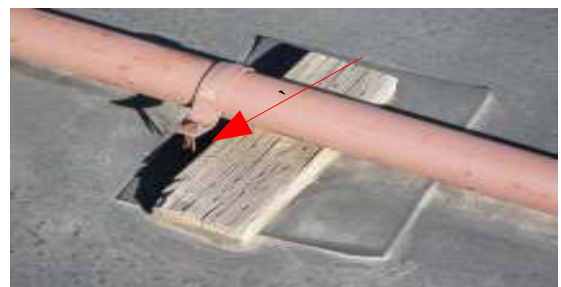
Some gas piping has deteriorated paint (left photo). Some gas piping standoff blocks on the roof are deteriorated or missing (right photo).

Recommendations: Repair standoff blocks and the hot/cold reversed faucets, Replace the cracked urinal. Label the gas piping.

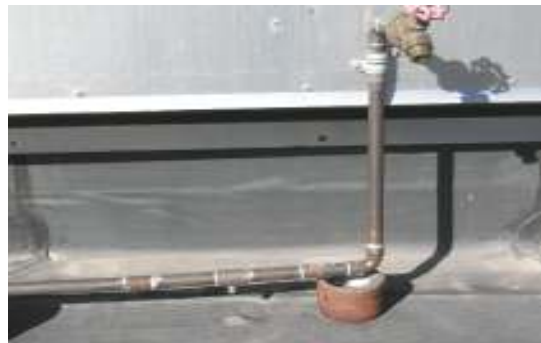
There is a tenant-added copper water line on south lower roof which has a dead-end slope that will trap water and freeze in winter. **The supply line shutoff valve must be closed (mechanical room), and the relief valve on the roof must be opened to drain the line before freezing weather.** This line appears to have a **small leak** toward the south end.

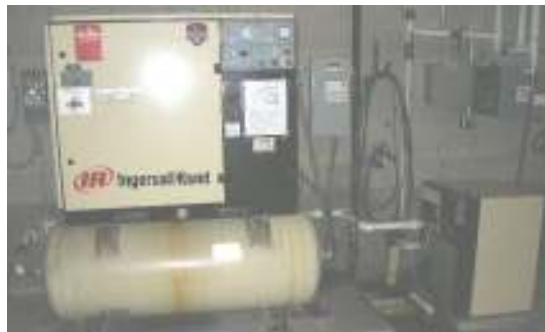
No record of a recent “unfired pressure vessel” pressure test– **safety issue**

Recommendations: Continued monitoring and maintenance; test the air tanks.

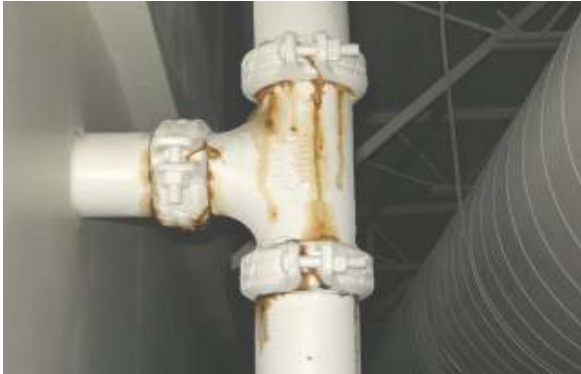
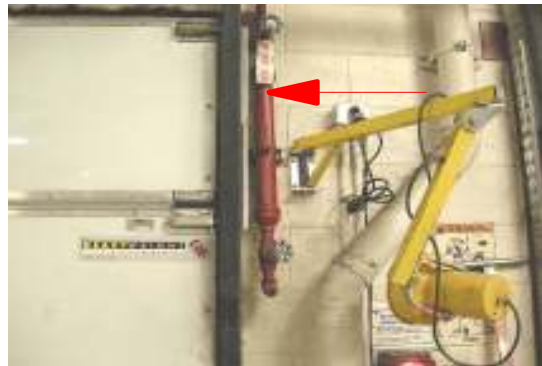
This dry pipe system has **substantial evidence of leaking joints** (pipes are not painted red in all locations). **Maintenance personnel report that the piping is thin gauge, not heavy gauge. Future repairs should be expected.** This system has **double-valved auxiliary drains** (right photo) from which **the condensate should be drained each month.** The dry pipe system prevents freezing in the fire sprinkler heads which are located outside the dock doors.

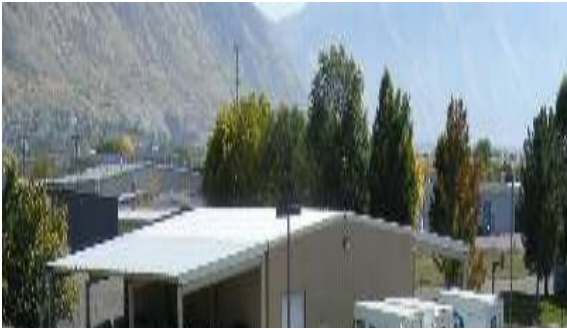
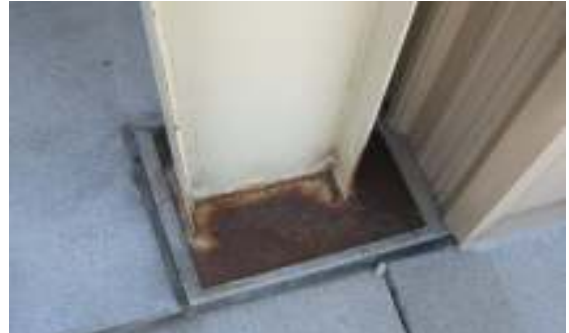
The property includes a detached steel building, approximately 3500 square feet, on the southeast corner of the lot; no signs of leaks. The exterior pillar bases of the steel building have rust
