Expert Commercial Building Inspections LLC

Property Condition Report 369 South 900 East, Salt Lake City Utah 84106

Inspector: Garrett Merrick
Inspection Date: March 2012
County Property #123456789

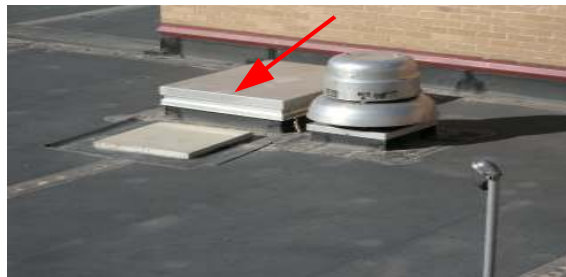
Security item: this roof hatch (south lower roof) was unlocked on the day of the inspection, allowing for the possibility of unauthorized building access.

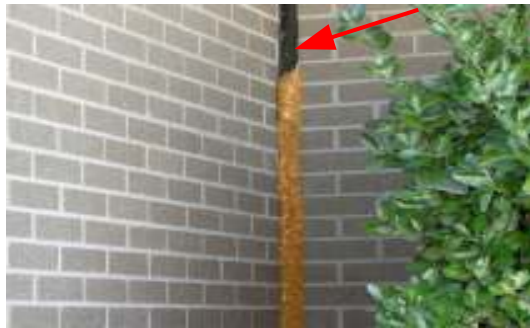
Exterior wall covering is mostly brick with windows on the north side and dock doors on the south side. Exterior roof antenna cords enter the building through window framing on the north side. The missing filler in the expansion joints should be replaced to provide energy insulation. The exposed filler should be painted to prevent deterioration from weather exposure.

1. Paint expansion joint expanding foam to prevent deterioration.
2. Repair soffit and fascia areas above the dock doors.
3. Repaint the step-down ledge in the truck parking lot.

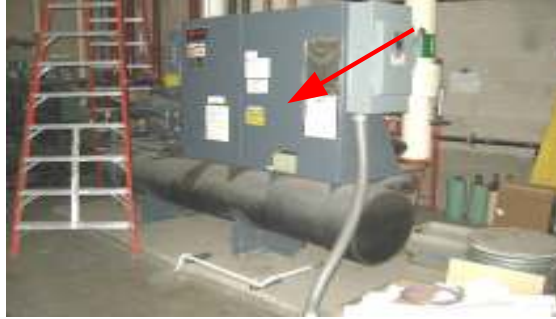
- computer controlled; program installed by Carrier Corp. (2011); check with owner for passwords and operation instructions
- uses R-22 refrigerant;
- reported as a 120 ton chiller
- dual (2 circuits) 3-stage compressors, lead/lag, 3Ø, 460V; no horsepower is listed
- both compressors are operational and produce chilled water at the setpoint (currently 50°)
- alarm package has been installed
- has manual electrical disconnect
- **CAUTION** – two electrical disconnects (including condenser) are required to de-energize the chiller
- gas mufflers, filter driers, insulated suction lines
- features: two refrigerant circuits, TVX meters, valved oil pressure gauges; valved high/low refrigerant pressure gauges (one is missing)
- oil level (sight glass) is satisfactory in both compressors
 - some air bubbles in refrigerant sight glasses usually indicates that an addition of refrigerant is needed

- EPA refrigerant records must be maintained for this equipment; check with the owner

1. Add refrigerant to the chiller
2. Verify that the owner has the required EPA refrigerant records.
3. Repair heating mode in RTUs 2 and 4.
4. The HVAC equipment should be monitored and maintained monthly by qualified technicians or a commercial HVAC company.

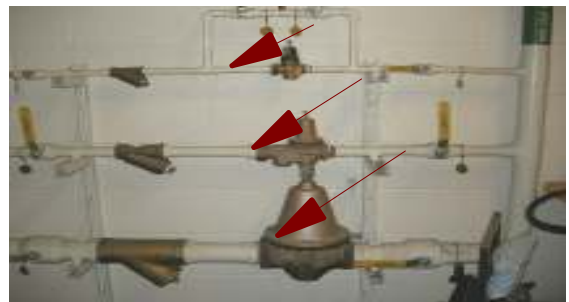
- There are 3 pressure reducing valves (PRV) (3/4, 1-1/4, and 3")
- The non-working (shut off and isolated) 1-1/4 PRV does not appear to have any adverse effect on the water supply system.
- Pressure is reduced to 48psi (on the day of the inspection)
- More down-line shutoff valves are located in the mechanical room

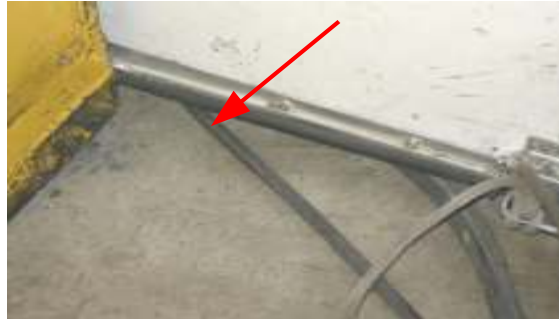
No flexible cords being improperly used as substitutes for the fixed wiring of a structure or running through walls, ceilings, floors, doorways, windows, or under carpets was observed. One machine **wiring cord runs under dock door #27 (compactor), a safety hazard.**

1. Replace junction box missing covers.
2. Replace failed GFCI receptacles.
3. Re-route the machine wiring cord that runs under a dock door.

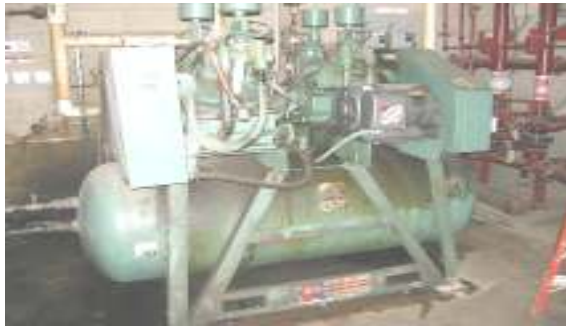
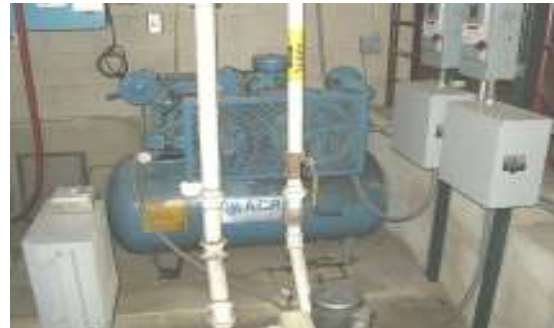
Has small oil leaks

Has air dryer

Safety Issue: No record of a recent “unfired pressure vessel” pressure test.

Recommendation: Perform the unfired pressure vessel safety tests on the air compressors.

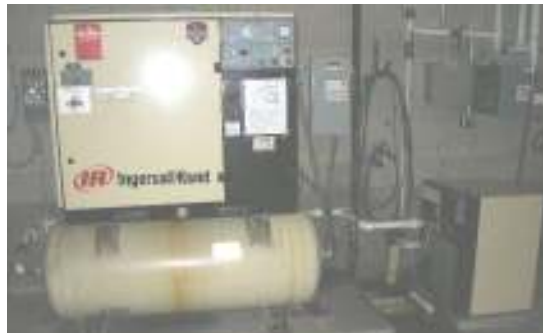
3. Ingersoll-Rand rotary air compressor

Single motor; 30hp, 3Ø, 460V

has small oil leaks

Has air dryer

Safety Issue: No record of a recent “unfired pressure vessel” pressure test.

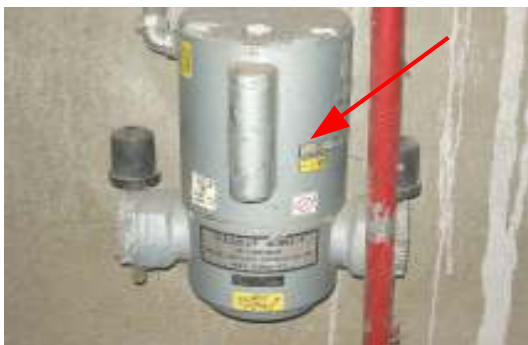
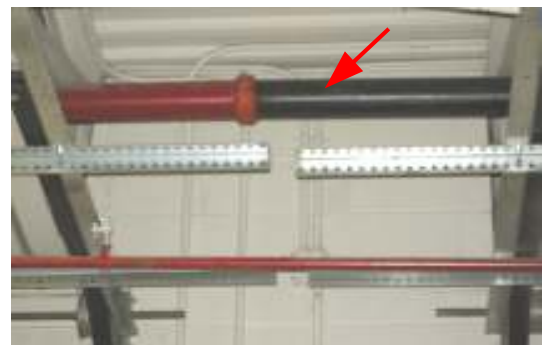
The dry pipe system has a [noisy air compressor](#) (mechanical room); it appears to be original (as reported by building maintenance staff) and may need to be replaced in the near future. Evidence of repairs (unpainted pipe) to this system is visible in the mechanical room and on the dock.

This dry pipe system has substantial evidence of leaking joints (pipes are not painted red in all locations). Maintenance personnel report that the piping is thin gauge, not heavy gauge. Future repairs should be expected. This system has double-valved auxiliary drains (right photo) from which the condensate should be drained each month. The dry pipe system prevents freezing in the fire sprinkler heads which are located outside the dock doors.

1. Monitor the dry pipe joints; replace as needed.
2. Inspect the portable fire extinguishers upon occupancy and correct as needed.
3. Repair the emergency lighting units (replacing the battery usually fixes them).
4. Repair fire doors and fire dampers as needed.

| Item | Estimated Cost |
|--|---|
| Repair dry pipe fire sprinkling system | \$30,000.00 |

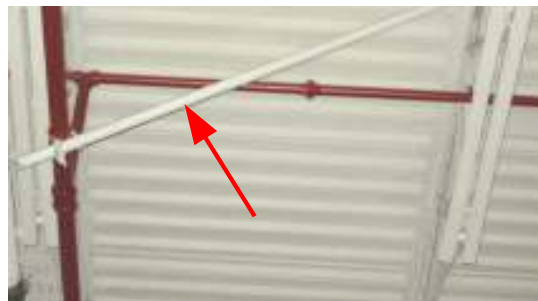
Fire sprinklers have been installed throughout the building. There was no visible evidence that sprinklers have been painted, other than at the factory. The fire sprinkler for the “green” room (SE) is located [above the suspended ceiling](#); the construction of this room appears to be a tenant modification. Spare parts for the fire sprinkling systems are on hand in the small red wall cabinets in the southwest corner of the mechanical room . There is a water gong and fire department hose connections on the south side of the building outside the mechanical room. Fire sprinkler heads should be inspected periodically. Earthquake bracing has been installed.

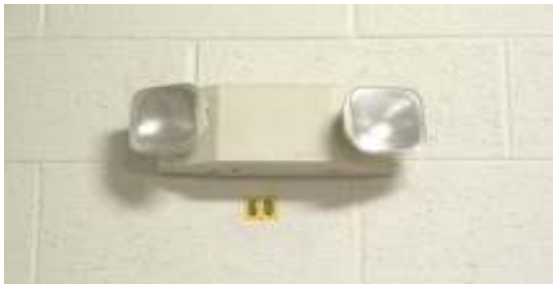
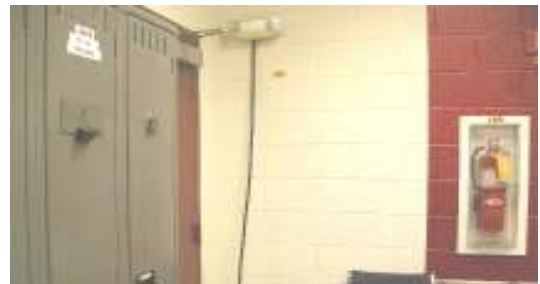
Emergency lighting units and lighted exit signs have been installed throughout the building. Most of the units on the east half of the building are self-contained rechargeable battery types. Most are working, but [some are not](#).

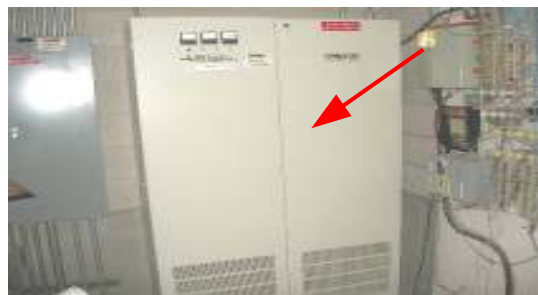
The emergency lighting and lighted exit signs on the west half of the building appear to be controlled from the emergency power cabinet (photo) in the southeast corner of the mechanical room. This cabinet contains nine 6-volt batteries connected in series, with a power converter that converts the 54-volts into 277 volts to power the 277-volt emergency lights. The batteries in this cabinet appear to be several years old and may need to be replaced in the near future. The emergency lights of the west workroom floor are ceiling-mounted fluorescent fixtures.

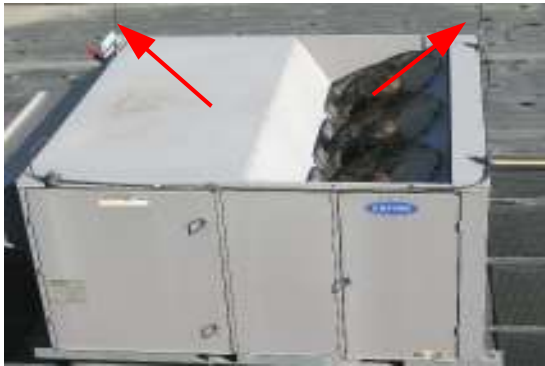
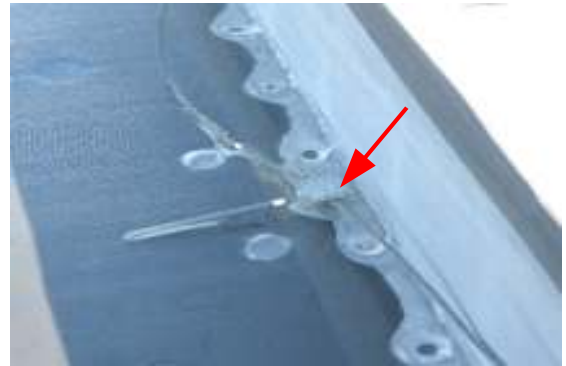
Missing air terminals on RTUs 1 and 3 (left photo)

Some glued LPS connections to the parapets and roof surface have come loose (right photo)

Recommendations: Repair or replace missing air terminals on the lightning protection system.
