Commercial Building Inspection
Lincoln Avenue, Las Vegas NV 89111
Clark County Property Serial Number 2233445566

Inspector: Garrett Merrick
Inspection Date: 12 March 2012

Building Overview

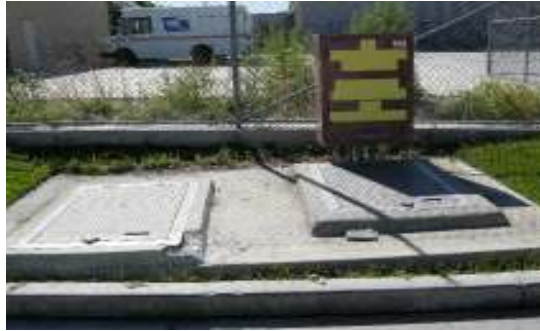
- missing splash blocks on north grass area (see Roof Drains above)
- steel grates on drainage pits appear serviceable
- drainage pits appear to be functioning properly, but some have leaf buildup in the bottom, and some near the SW employee entrance have cigarette butt buildup
- the south truck parking area has storm water drains and a sump pump.
"Confined Space" – DO NOT ENTER unless specially trained and equipped.

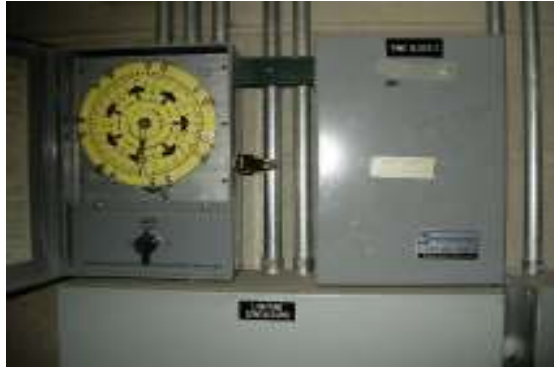
- consists of pole lights, soffit lights, and wall lights
- all are controlled by lighting “timers”; some also have light sensors mounted on the roof
- most are operational; **some exterior lights were not working**
- some outside lighting “timer” panels have been **rewired and bypassed** (mechanical room)

- lights at base of northeast flagpole do not work; an alternate flag light has been installed on the light pole to the west of the flagpole
- Exterior **light has been removed** under the west parking canopy.

Recommendations: Replace failed GFCI receptacles. Rewire at the compactor so the wire does not run under the door.

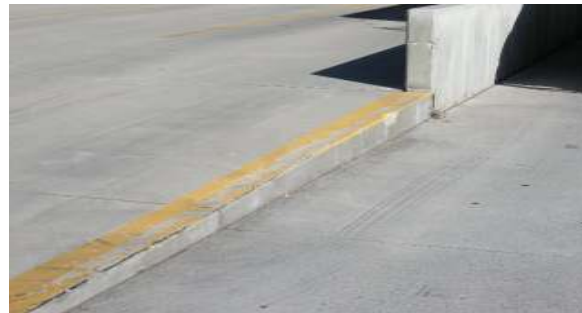
Faded paint on step-down ledge in truck parking lot by doors 3 & 4

Recommendations: Repair expansion joints and railing. Repaint parking lot step hazard.

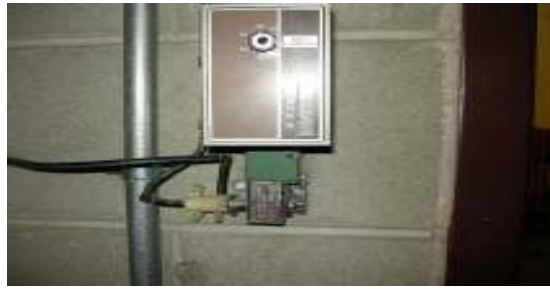
Combustion air is drawn from two mechanical room ducts: one to the south wall; one to the roof with a computer controlled damper – **not operational on the day of the inspection**. There is a temperature controlled (wall switch) roof exhaust fan to keep the mechanical room cool.

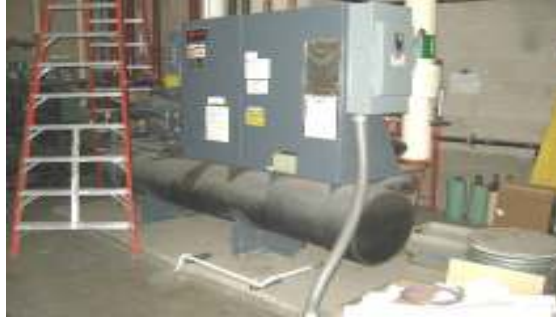
- oil level (sight glass) is satisfactory in both compressors
 - **some air bubbles** in refrigerant sight glasses; usually indicates that an addition of refrigerant is needed

- EPA refrigerant records must be maintained for this equipment; check with the owner

Recommendations: Repair the heating function in two RTUs and protect the control wires that are in potentially damaging locations. The HVAC equipment should be monitored and maintained monthly by qualified technicians or a commercial HVAC company. [EPA refrigerant records must be maintained for the 120-ton chiller.](#)

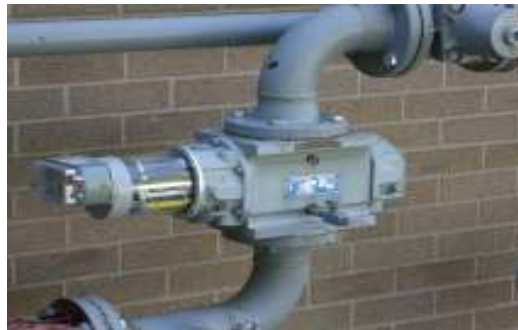
The natural gas meter, with regulator and [gas shutoff valve](#), is located on the [north side](#) (center) of the building. No earthquake shutoff valve is installed (not required). There is [no separate shutoff valve](#) for the welded steel gas lines on the roof, but each appliance has its own shutoff valve

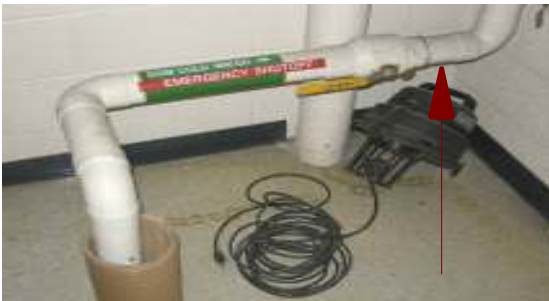
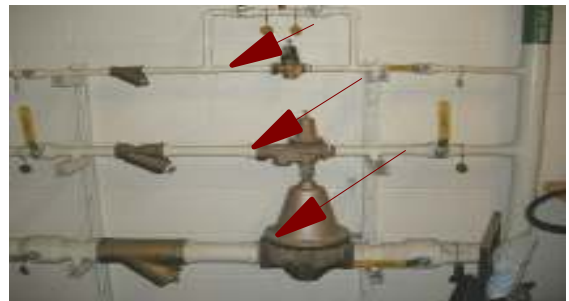
- There are 3 pressure reducing valves (PRV) (3/4, 1-1/4, and 3")
- The 1-1/4 PRV does not work; is shut off and isolated
- Pressure is reduced to 48psi (on the day of the inspection)
- More downline shutoff valves are located in the mechanical room

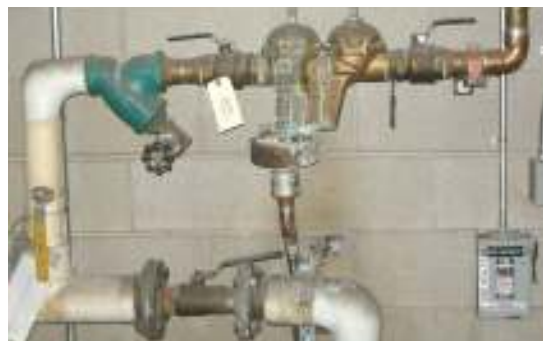
A backflow preventer to prevent a cross-connection between the potable water distribution system and the non-potable water is located in mechanical room; it was tested May 2011. [Test the backflow preventer yearly.](#)

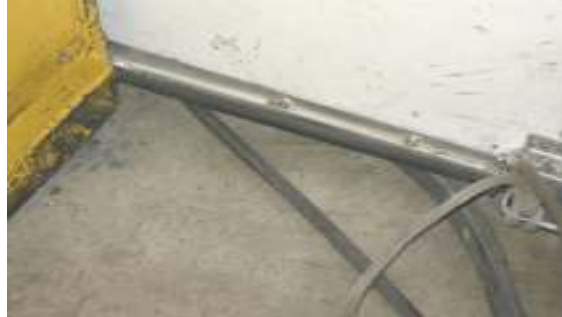
One **junction box where the cover had not been replaced** was observed on the east dock. No open wiring splices were observed. All receptacles near sinks were GFCI protected. **Two GFCI receptacles failed**: one on the breakroom counter, and one in the Contract Drivers women's restroom. No solid conductor aluminum branch circuit wiring was visible.

No flexible cords being improperly used as substitutes for the fixed wiring of a structure or running through walls, ceilings, floors, doorways, windows, or under carpets was observed. One machine **wiring cord runs under dock door #27** (compactor).

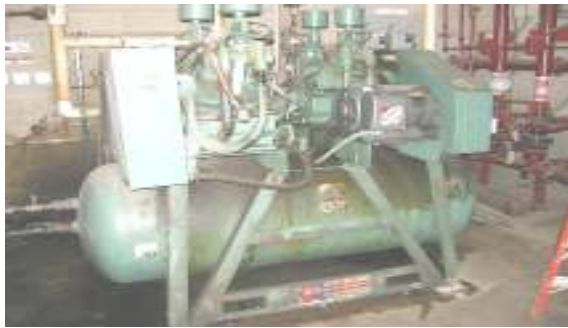
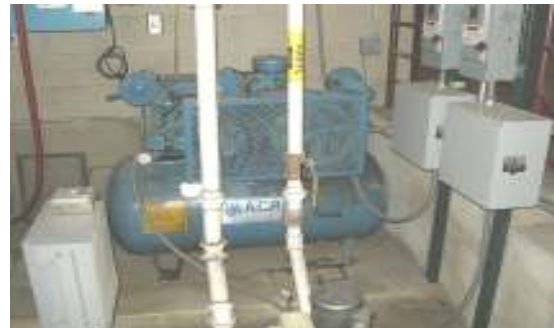
No record of a recent “unfired pressure vessel” pressure test– **safety issue**

Air-intake filters require periodic maintenance

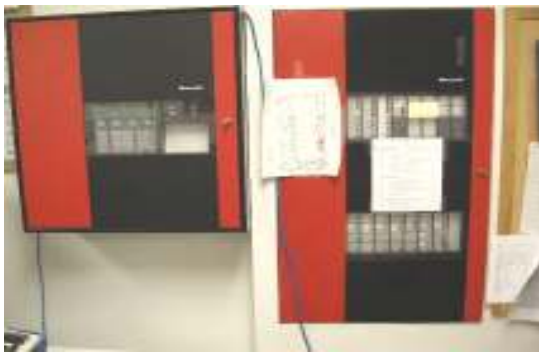
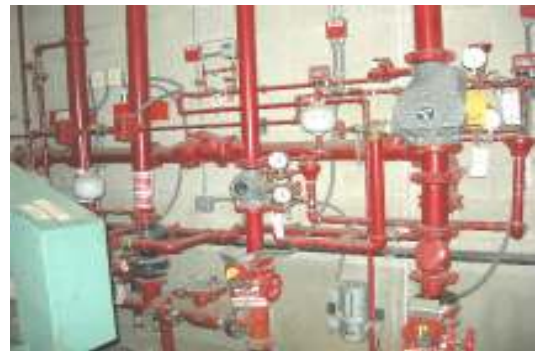
A supervised (monitored) fire alarm system, with manual actuators installed throughout the building, has been installed. Records of the previous occupant indicate that the system **has been inspected yearly**. The Delta FS90 fire alarm panel is located in the "supervisors' office" on the north side and is accessible. This system also monitors fire sprinkling system water valves which are located in the mechanical room. **The shunt trip circuits (equipment shut off) have been modified to allow for fire alarm system testing.**

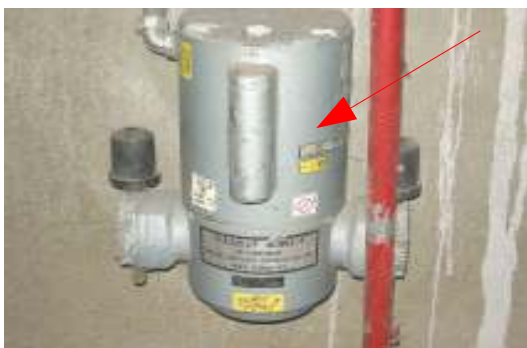
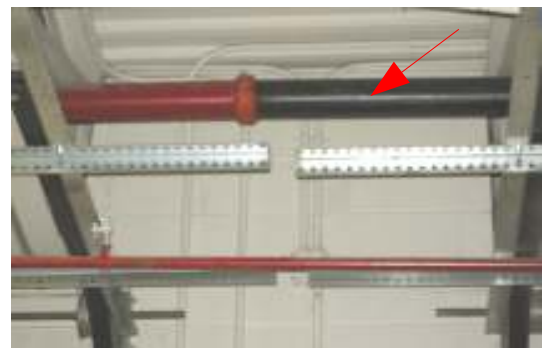
The dry pipe system has a **noisy air compressor** (mechanical room); it appears to be original (as reported by building maintenance staff) and may need to be replaced in the near future. **Evidence of repairs** (unpainted pipe) to this system is visible in the mechanical room and on the dock.

This dry pipe system has **substantial evidence of leaking joints** (pipes are not painted red in all locations). **Maintenance personnel report that the piping is thin gauge, not heavy gauge. Future repairs should be expected.** This system has **double-valved auxiliary drains** (right photo) from which **the condensate should be drained each month.** The dry pipe system prevents freezing in the fire sprinkler heads which are located outside the dock doors.

Any cost analysis which is provided is strictly an opinion of probable costs for the repair or replacement of building components which were found to be in need of immediate repair or replacement, or as applies, to those items that will be at the end of their useful life in five years. The opinions are subject to argument as conditions have changed, and are changing currently (use, weather, depreciation, occupancy effects, etc.). The opinions of probable cost are intended solely as an indication of the approximate nature and scope of repair, and the owner or purchaser cannot rely upon them as indicating actual nature, scope, and cost. Firm costs can only be ascertained by obtaining bids from qualified contractors. Other costs, such as ongoing maintenance and improvements, can be expected. The only item found which is likely to exceed the \$3000 limit is the possible repair or replacement of the leaking dry-pipe system pipes. Repair is not required at this time, but the system needs to be monitored.

Item	Estimated Cost
Repair dry pipe fire sprinkling system	\$30,000.00
Total Estimate	\$30,000.00

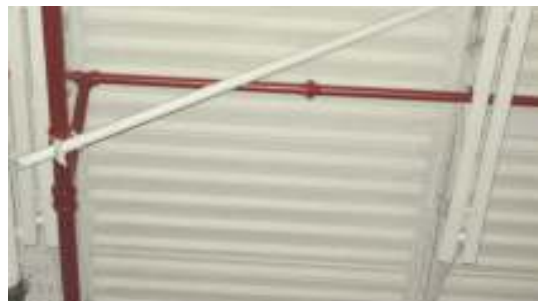
Fire sprinklers have been installed throughout the building. There was no visible evidence that sprinklers have been painted, other than at the factory. The fire sprinkler for the “green” room (SE) is located **above the suspended ceiling**; the construction of this room appears to be a tenant modification. Spare parts for the fire sprinkling systems are on hand in the small red wall cabinets in the southwest corner of the mechanical room . There is a water gong and fire department hose connections on the south side of the building outside the mechanical room. Fire sprinkler heads should be inspected periodically. Earthquake bracing has been installed.

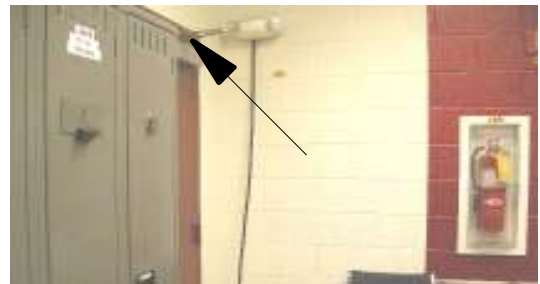
Emergency lighting units and lighted exit signs have been installed throughout the building. Most of the units on the east half of the building are self-contained rechargeable battery types. Most are working, but **some are not.**

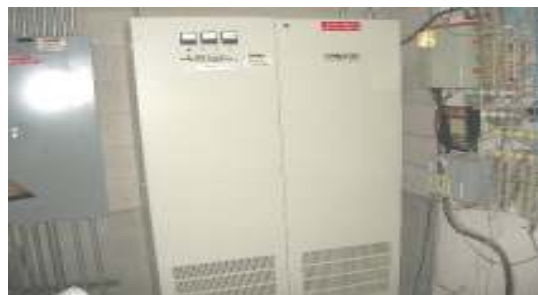
The emergency lighting and lighted exit signs on the west half of the building appear to be controlled from the emergency power cabinet (photo) in the southeast corner of the mechanical room. This cabinet contains nine 6-volt batteries connected in series, with a power converter that converts the 54-volts into 277 volts to power the 277-volt emergency lights. The **batteries in this cabinet** appear to be several years old and **may need to be replaced** in the near future. The emergency lights of the west workroom floor are ceiling-mounted fluorescent fixtures.

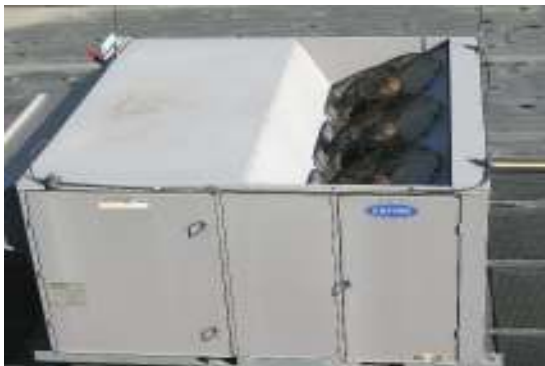
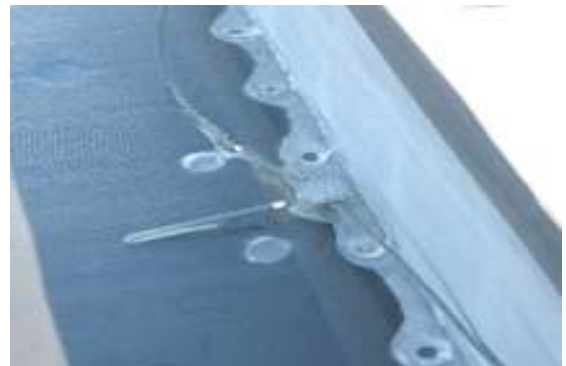
Missing air terminals on RTUs 1 and 3 (left photo)

Some glued LPS connections to the parapets and roof surface have come loose (right photo)
